HARBOUR BOARD

1st February 2019

Subject:	Whitstable Harbour Dredging Report
Director of Service:	Tricia Marshall, Deputy Chief Executive
Decision Issues:	These matters are within the authority of the Harbour Board.
Classification:	This report is open to the public.
CCC Ward(s):	Gorrell & Tankerton Wards
Summary:	<i>This report outlines dredging works at Whitstable Harbour.</i>
To Note	a. The current dredging regime is proving to be successful by carrying out the programme on an annual basis
Next stage in process:	Continue with the bathymetric surveys using land based surveying equipment to target specific areas of the harbour to maximise operational requirements.

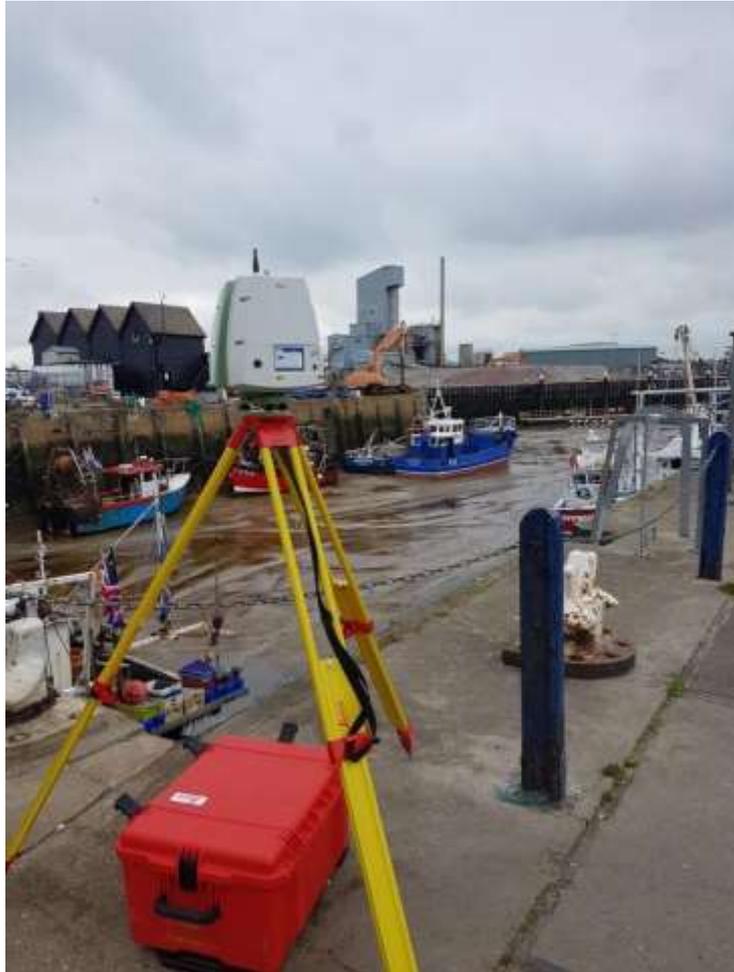
Figure 1: A Leica C10 Laser Scanner

On Sunday 29th April, Canterbury City Council (CCC) carried out a topographic survey of the seabed levels within Whitstable Harbour. A Leica C10 laser scanner (figure 1) was used to collect data from 10 locations around all quays on a spring low water to optimise exposure of the bed levels. The survey was accurate to +/-15mm. Traditionally, a bathymetric survey by boat was commissioned, however CCC decided to trial this method as it offered significant cost savings and health and safety benefits of not having personnel on water.

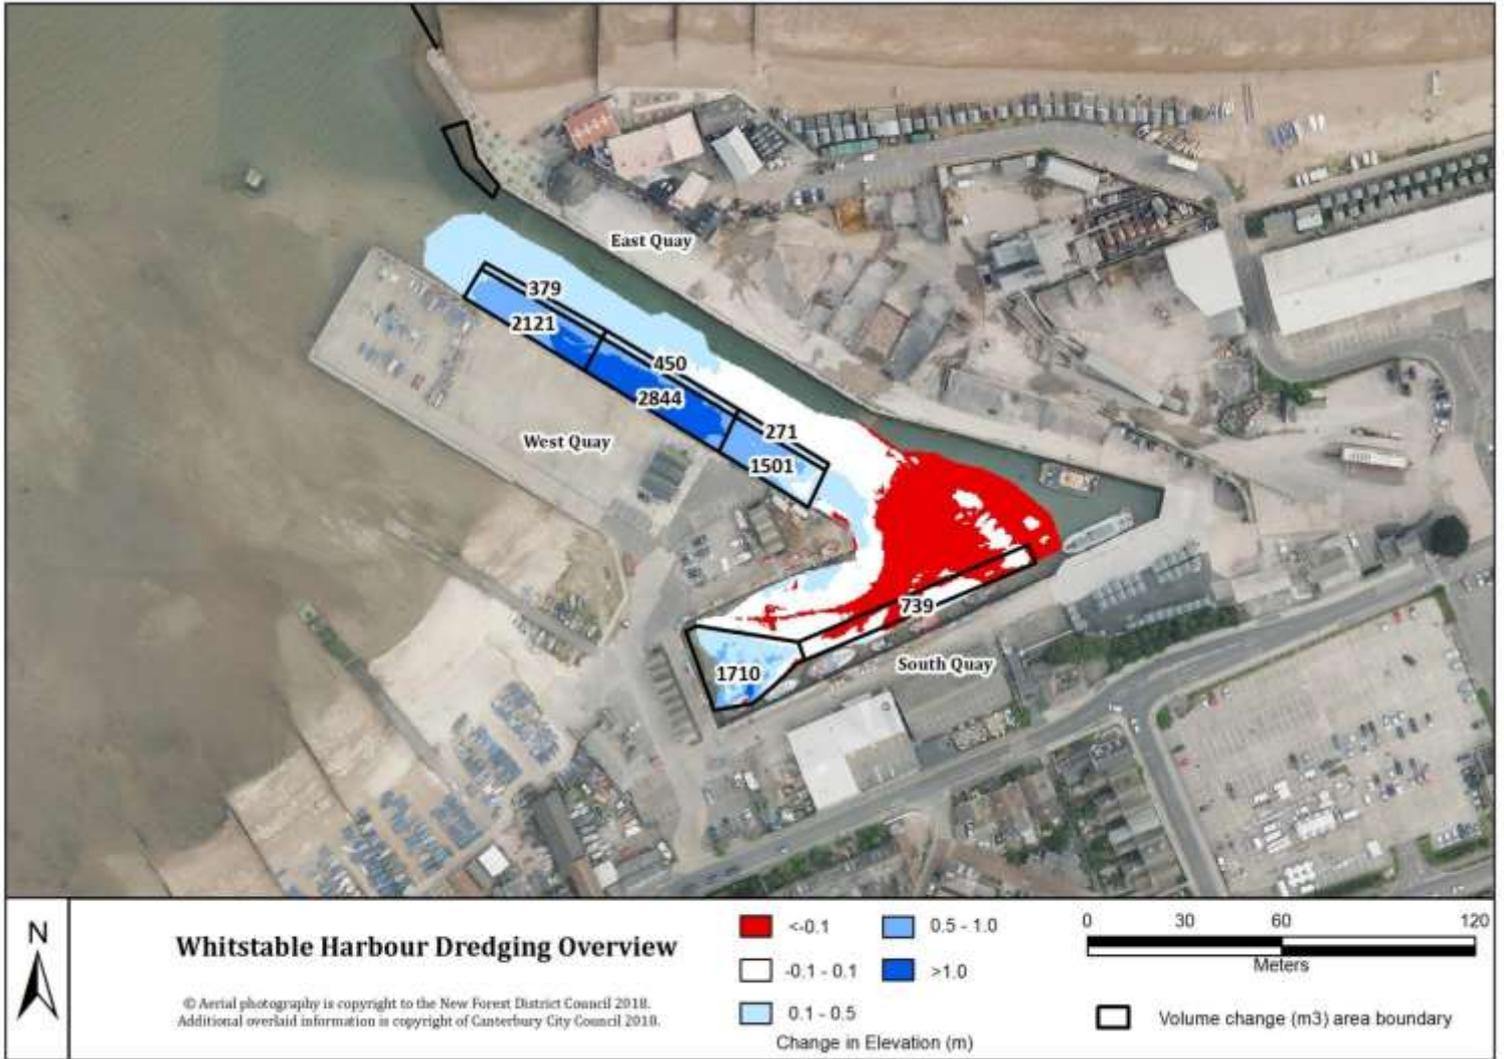
Figure 2: A model showing the differences in the surveyed height of the seabed and the design level. The polygons shown are areas in which need to be dredged, although not all can be dredged in one programme

The scanner collected a large dataset of the seabed levels within the harbour. Although, a limitation of this method is the laser reflects from any standing water, which causes gaps in the data. However, this is not considered a problem as any level lower than the standing water is an acceptable bed level. The data collected is then used to create a Digital Ground Model (DGM), which is compared to a further DGM of the design level of the seabed, with the basin being -2.3mOD and the outer harbour -2.5mOD. A difference model of the two DGMs, shown in Figure 2 is then created to illustrate where areas are above or below design level. A series of polygons are used to pinpoint areas where dredging needs to be undertaken to lower the levels of silt to design levels. The amount of material in cubic metres above design level can then be calculated.
